## **Silver Lake 2020 Aquatic Plant Survey Report**

November 11, 2020

Prepared for:  
**Silver Lake Protection Association**

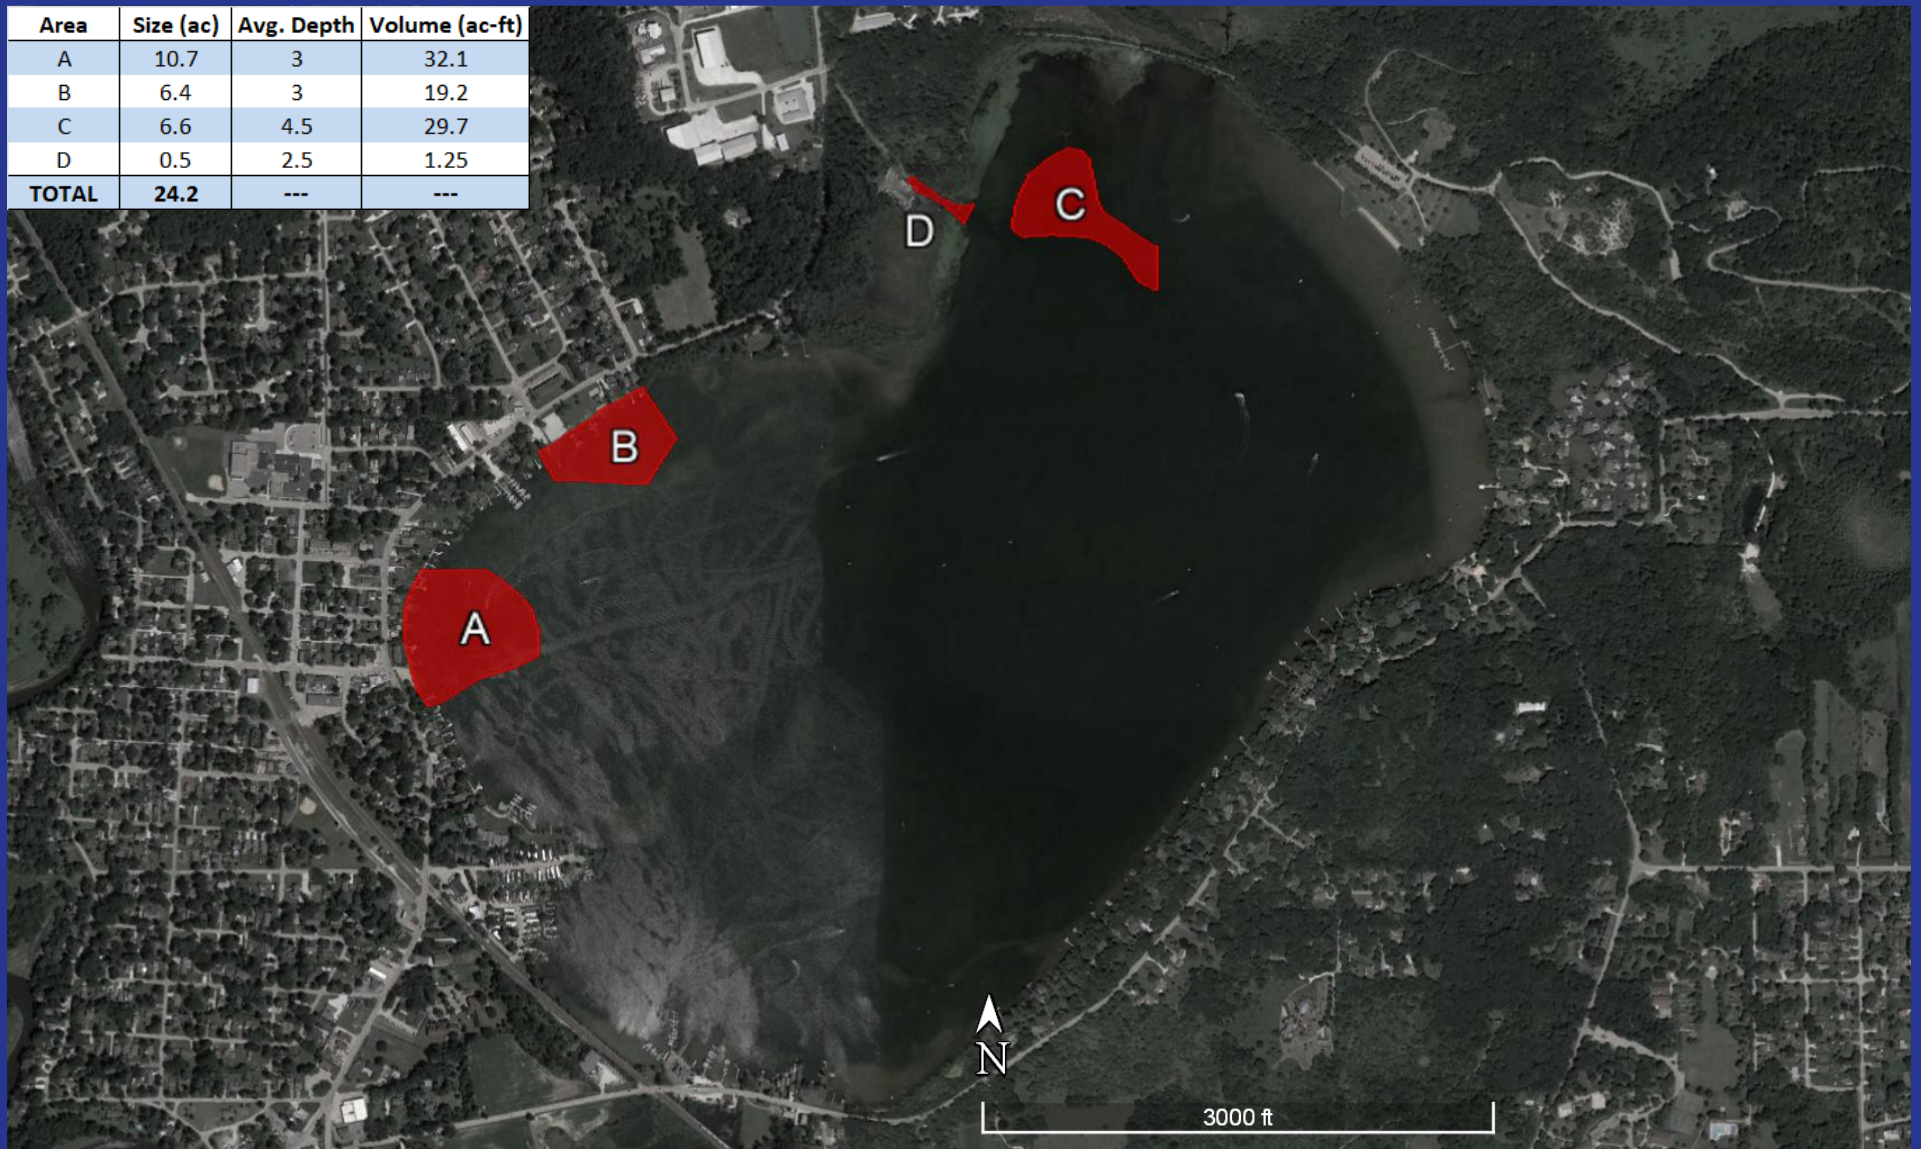
| Area | Size (ac) | Avg. Depth | Volume (ac-ft) |
| A | 10.7 | 3 | 32.1 |
| D | 0.5 | 2.5 | 1.25 |
| <b>TOTAL</b> | <b>24.2</b> | <b>---</b> | <b>---</b> |

Therefore, we recommend management in 2021 that focuses on reducing areas of the densest areas of HWM growth (Figure 3) with a highly targeted approach using ProcettaCOR EC to reduce impacts to non-target species. Any control should be coupled with continued monitoring and planning for 2022. For 2021 management, we recommend the following course of action:

- **February 2021:** Apply for WDNR permit for up to 24.2 acres for control of HWM (Figure 3).
- **May/June 2021:** Herbicide application for E/HWM control using ProcettaCOR EC. Rates are to be determined based on further discussion with the product manufacturer.
- **August/September 2021:** aquatic plant survey and mapping assess the HWM population
- **October/November 2021:** Complete an assessment of HWM present for 2021 planning
  - Update and submit management report and recommendations to the Association. Future planning may involve any of the following actions:
    - Varying scale of HWM control in 2022
    - WDNR AIS Grant application to assist in 2022 funding
    - Continued monitoring
